Manhole Inspection Summary

Manhole # S25KK1021MH

Insp Date: **11/7/06 10:58 AM**

Location Address: **4400 ROLAND AVE**

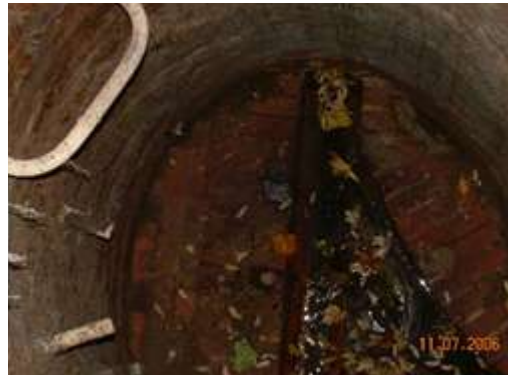
Top View

Adjustment, Corbel and Barrel root intrusion and infiltration. Corroded and missing steps. Evidence of surcharge.

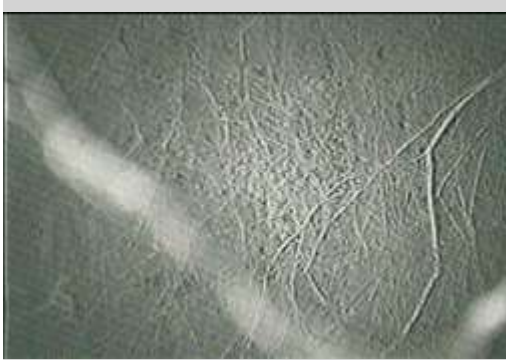
Defect

Condition: ☐ Sound ☐ Cracked ☒ **Root Intrusion** ☐ Loose Brick ☐ Deteriorated

Infiltration: ☐ None ☐ Joint ☐ Cracks ☒ **Mortar** ☒ **Roots** ☒ **Wall**

Barrel root intrusion and infiltration.

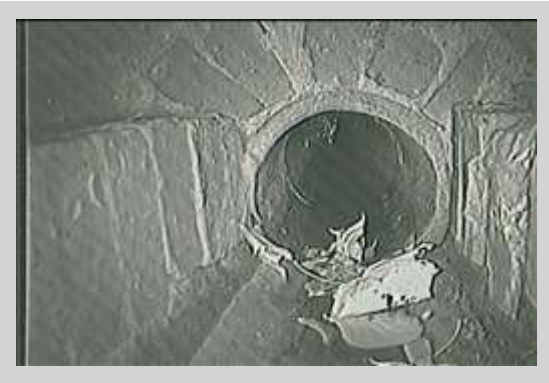
8 in. Circular Gravity Sewer Pipe Out @ 12 O'Clock

Rod and Bar (Angled)

Invert Depth: **10.60** (ft.) Flow Characteristics: **Slow**

Infiltration: **None** Pipe Seal Cond: **Unknown**

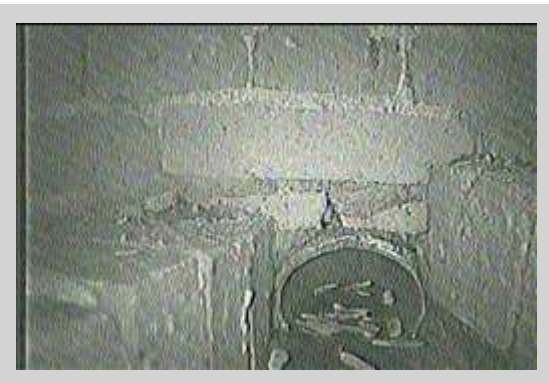
4 in. Circular Gravity Sewer Pipe In @ 4 O'Clock

Rod and Bar (Angled)

Deposits: ☐ None ☒ **Mud** ☐ Sludge ☒ **Debris** ☐ Grease

Silt Depth: **1** (in.) Deposits Extent: **Light**

Infiltration: **Evidence** Pipe Seal Cond: **Cracked**

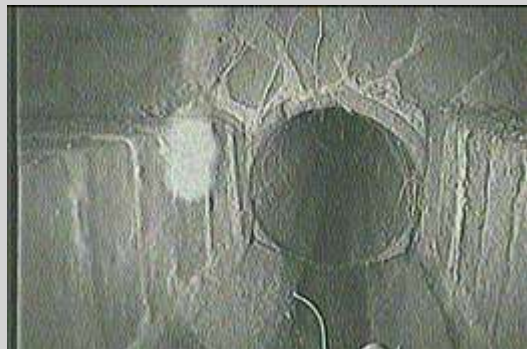
6 in. Circular Gravity Sewer

Rod and Bar (Angled)

Pipe Seal Cond: **Roots**
